**AGENDA
REGULAR MEETING
BOARD OF COMMISSIONERS
MONDAY, MAY 4, 2020
1:00**

Phase I Environmental Site Assessment
6785 46th Avenue North
St. Petersburg, Pinellas County, Florida

Prepared For:
Lealman Fire District

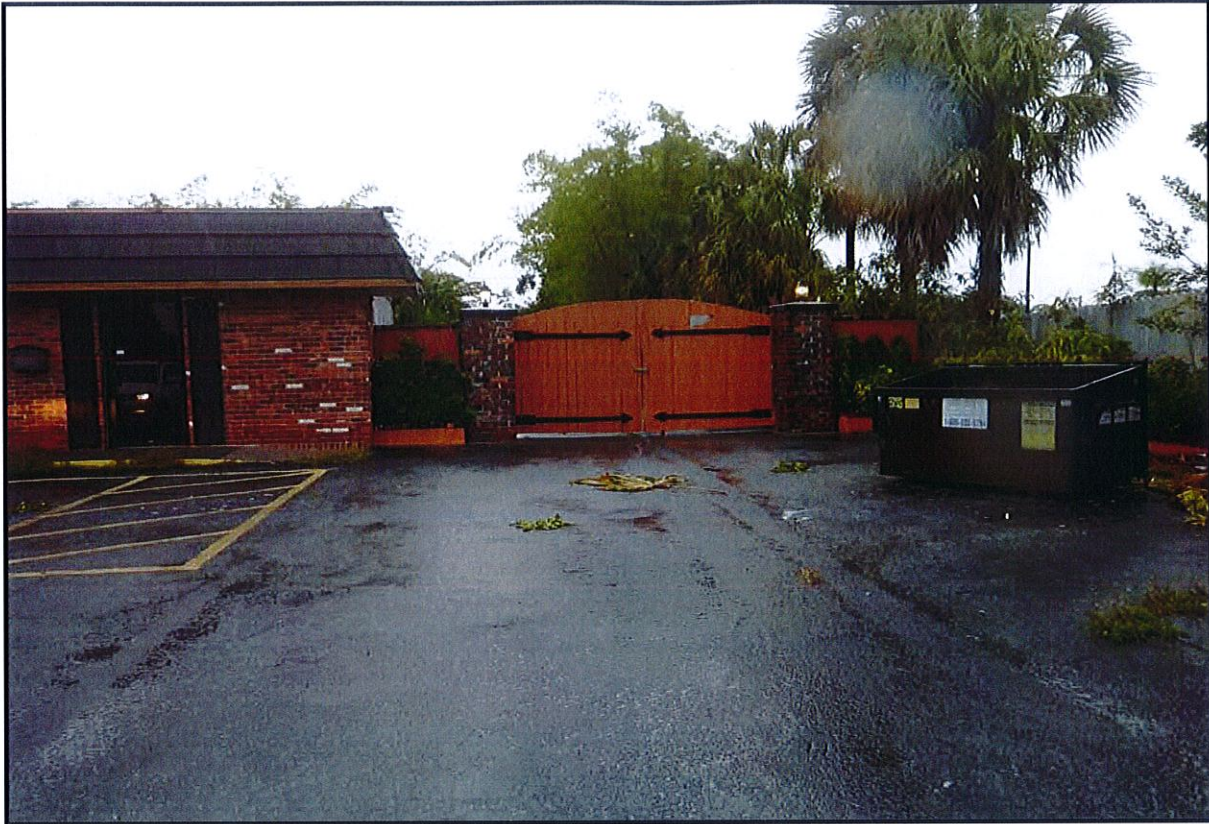
Photograph No. 3 View to the north of the eastern portion of the Subject Property and the commercial dumpster.

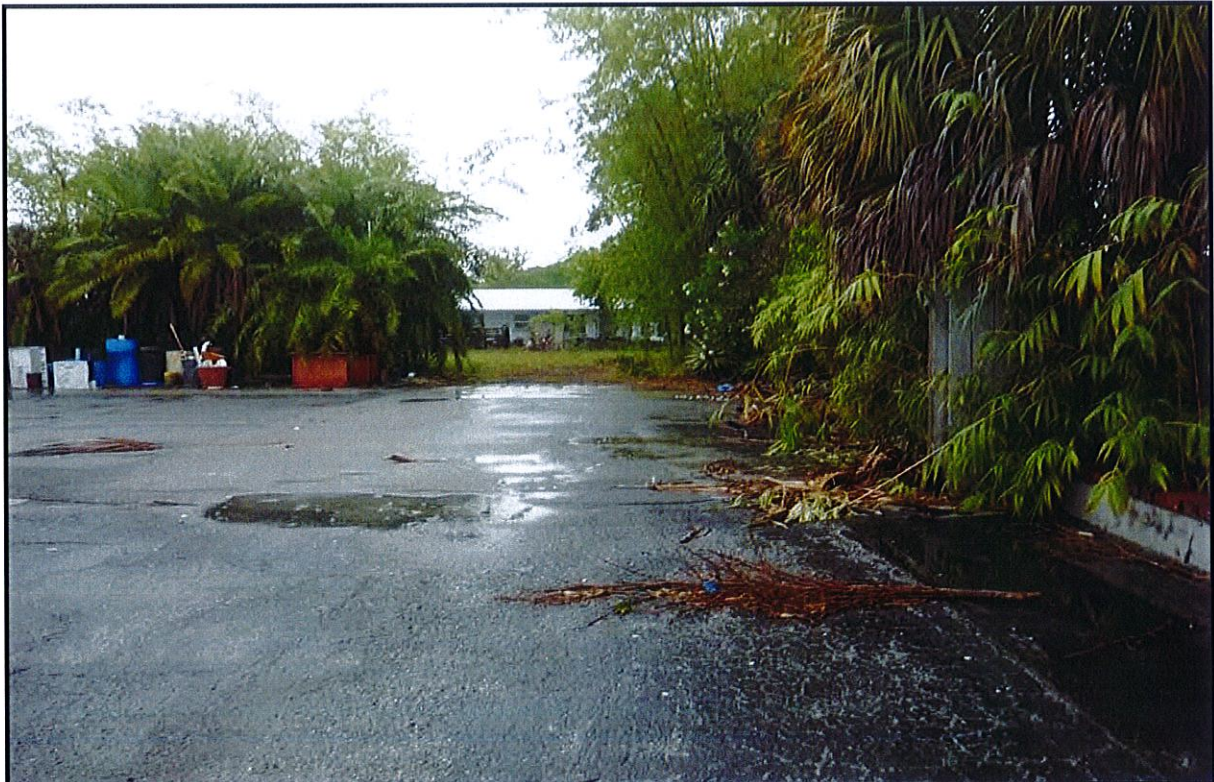
Photograph No. 4 View to the north of the western portion of the Subject Property. Note the furniture, PVC piping and fittings, and 55-gallon plastic drums containing rainwater to the left.

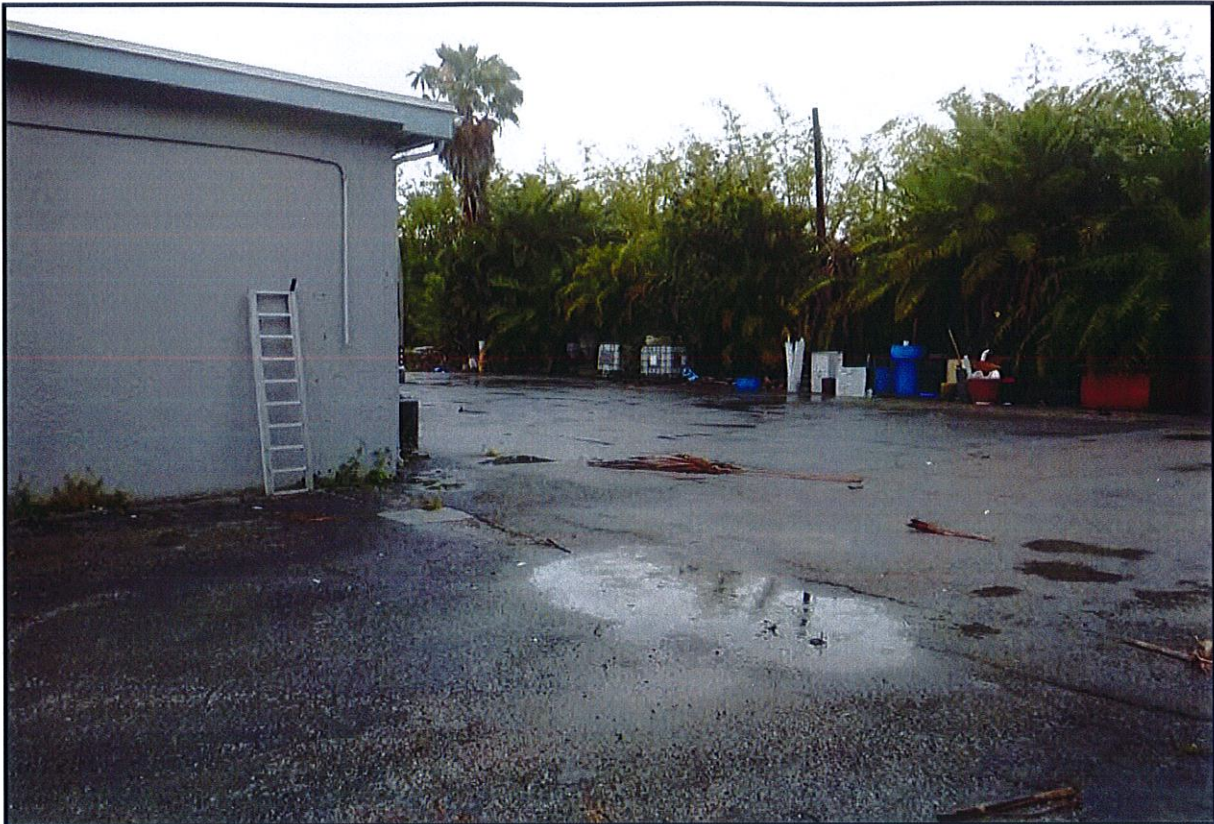
Photograph No. 5 View to the northwest of the furniture, PVC piping and fittings, 55-gallon plastic drums containing rainwater, two empty totes, two feed dispensers, and 5-gallon paint containers located on the central portion of the Subject Property.

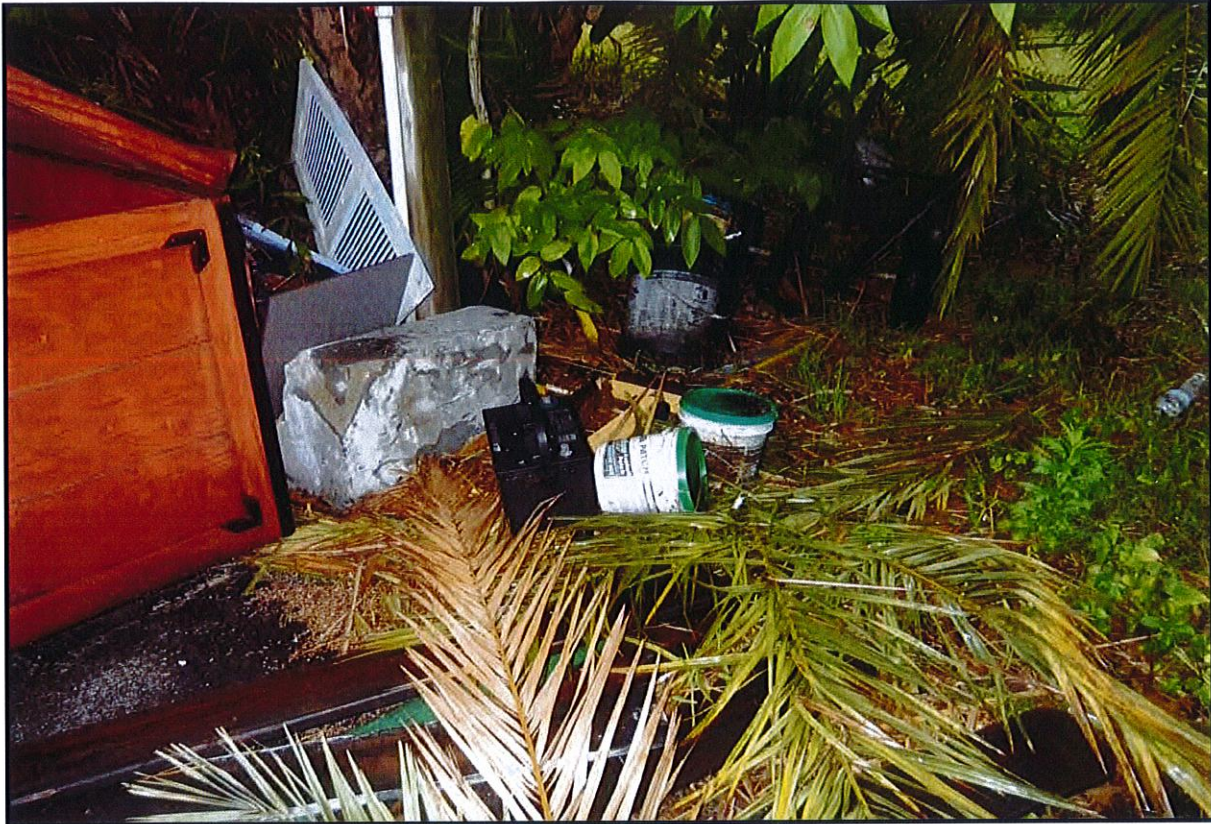
Photograph No. 7 View of a batter, two roof patch containers, and roof tar containers located on the central-eastern portion of the Subject Property.

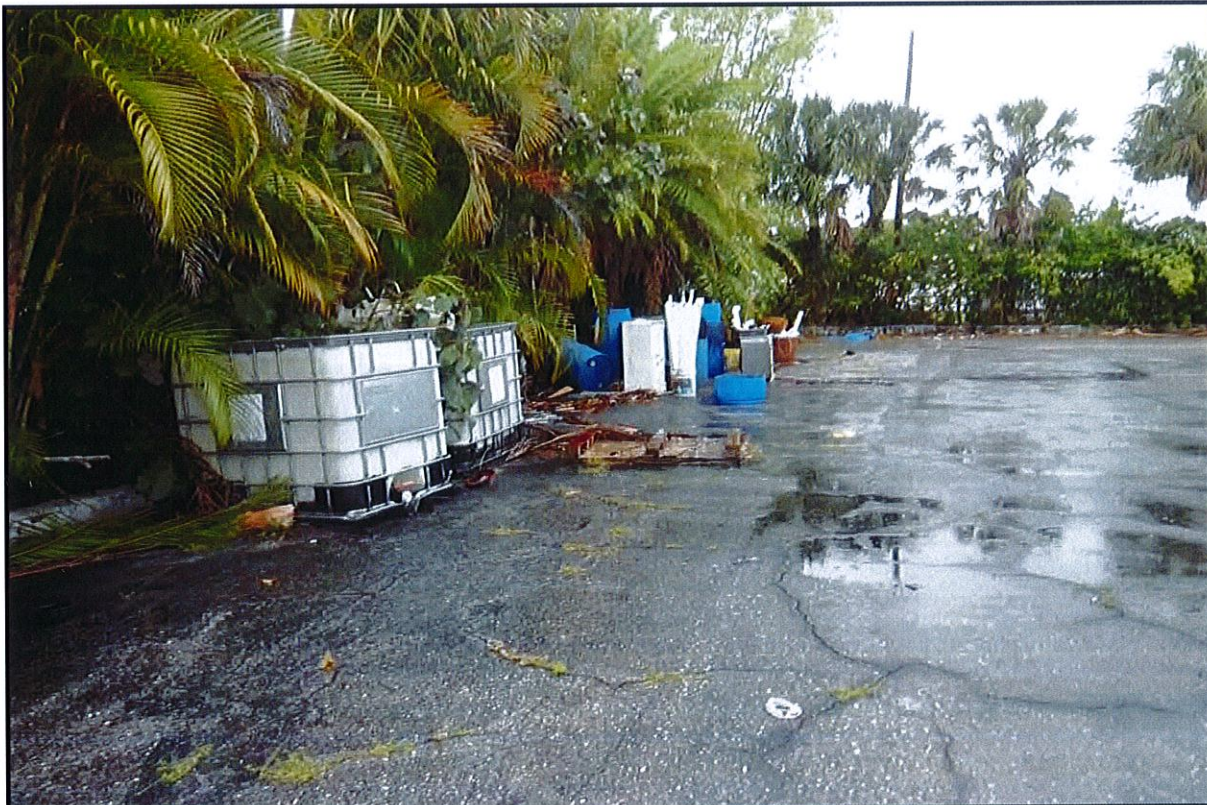
Photograph No. 8 View to the northeast of the two empty totes, 55-gallon drums, and furniture located on the central portion of the Subject Property.

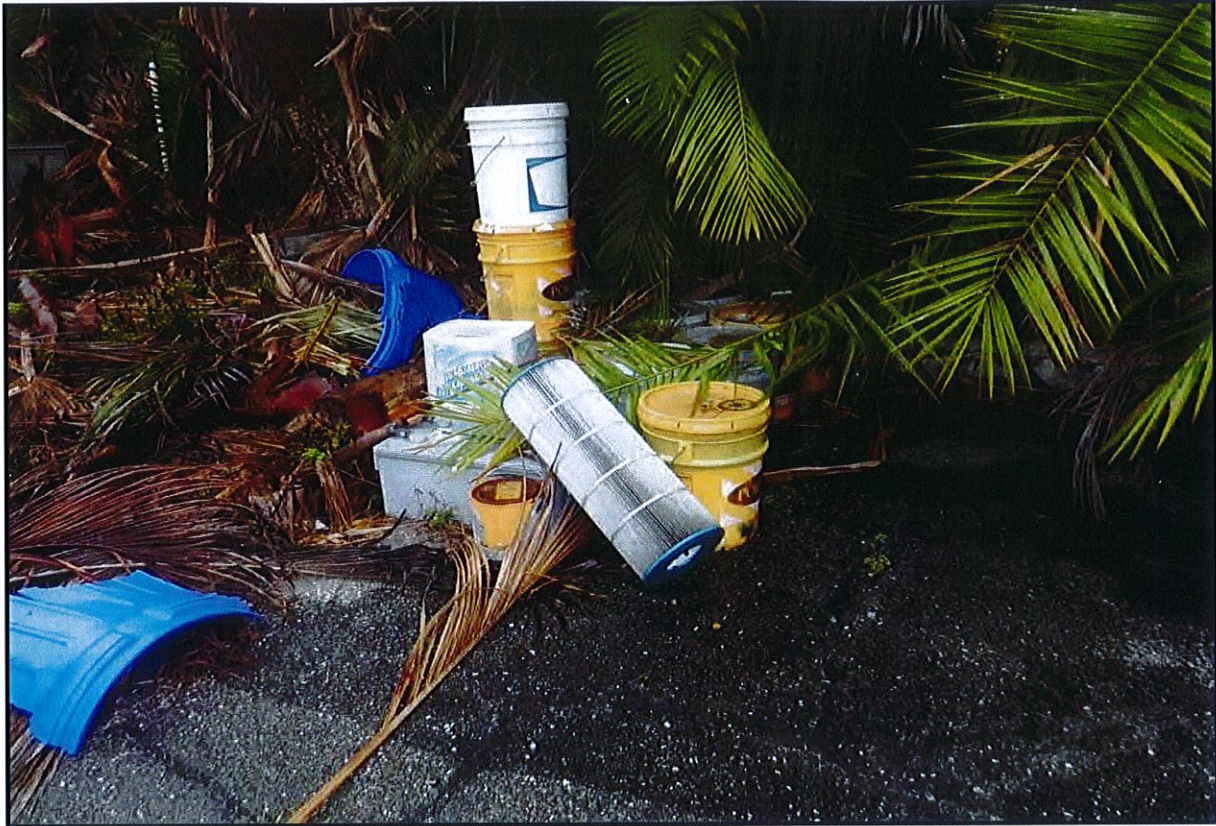
Photograph No. 9 View to the north of 5-gallon paint containers located on the central portion of the Subject Property.

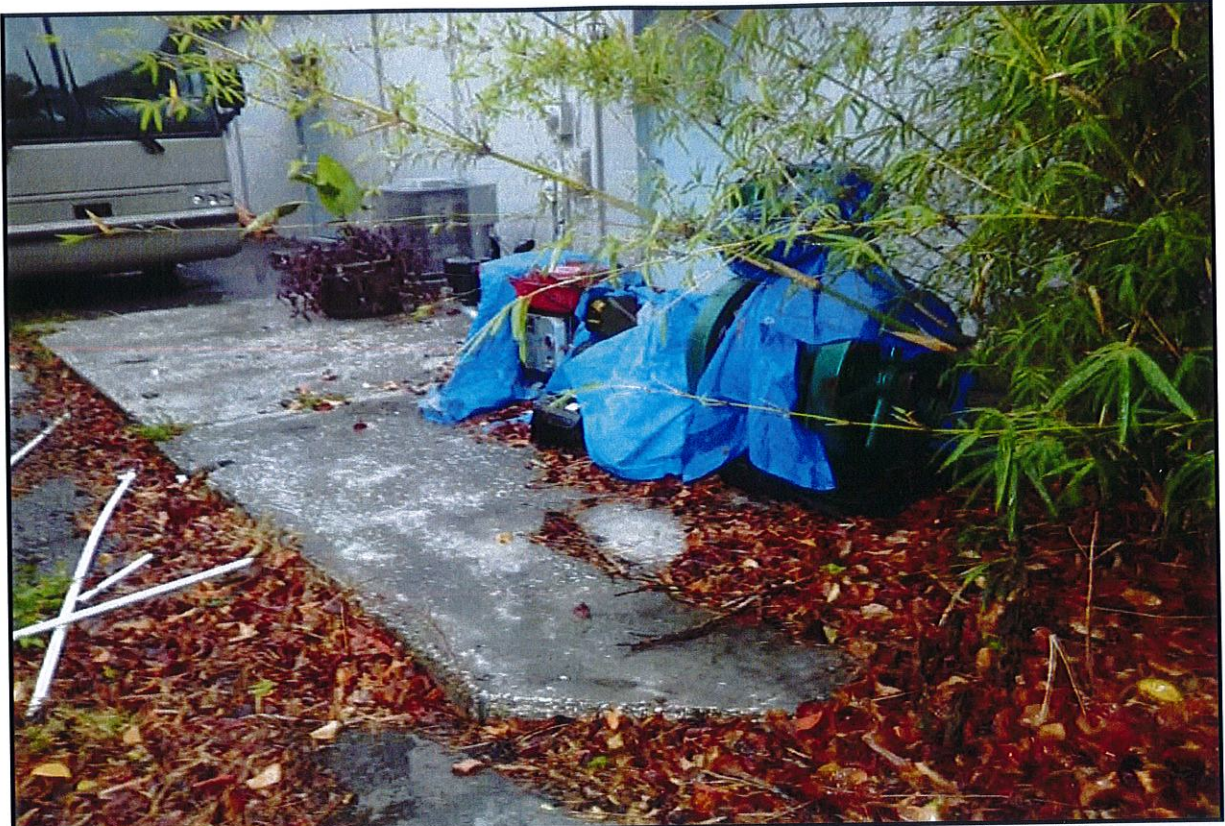
Photograph No. 11 View to the southeast of a motor located behind the onsite office building.

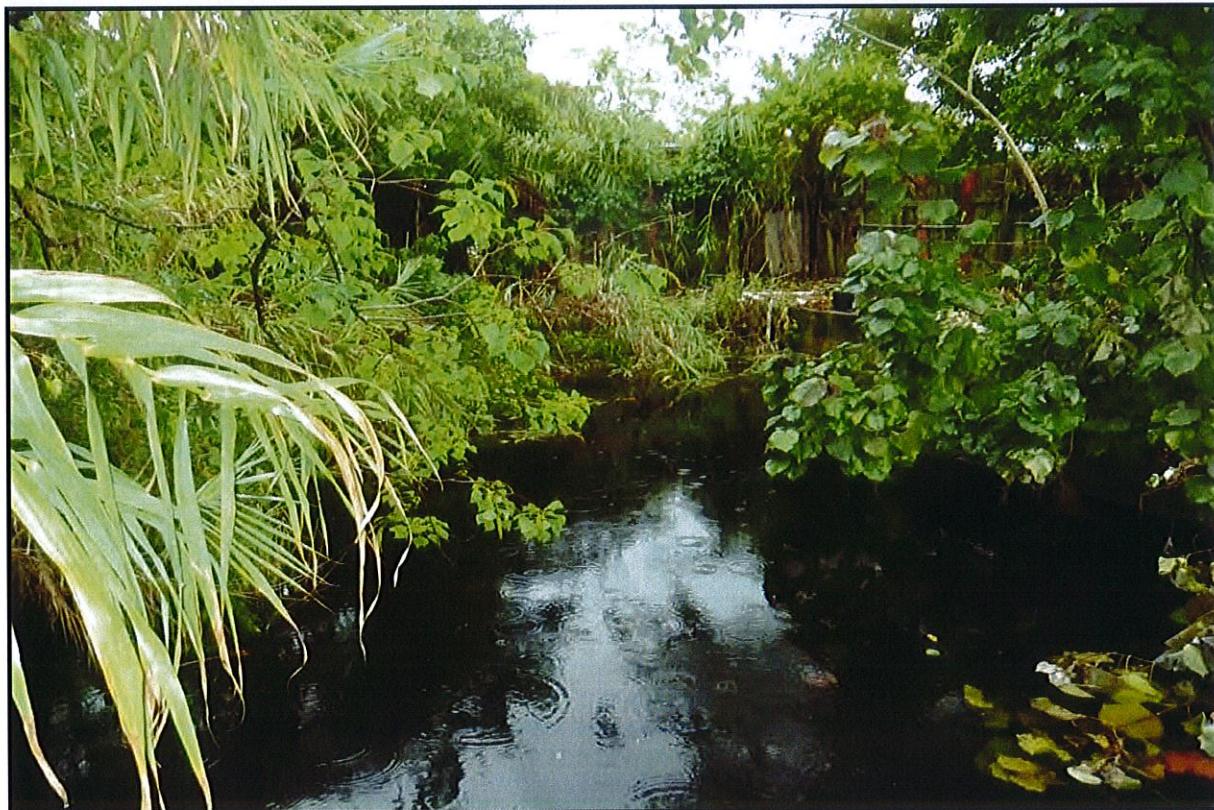
Photograph No. 14 View to the east of the man-made pond located on the northwestern portion of the Subject Property.

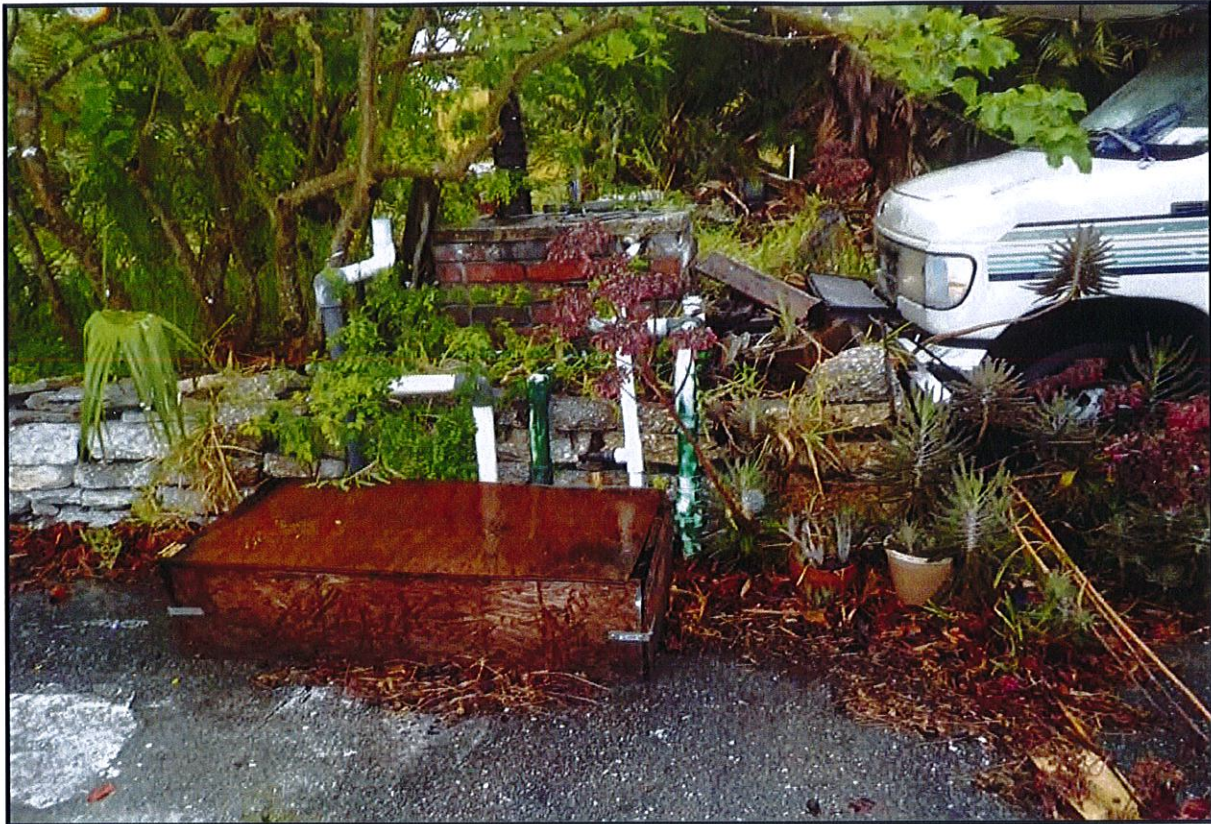
Photograph No. 19 View to the to the north of a potential irrigation well on the central-western portion of the Subject Property.

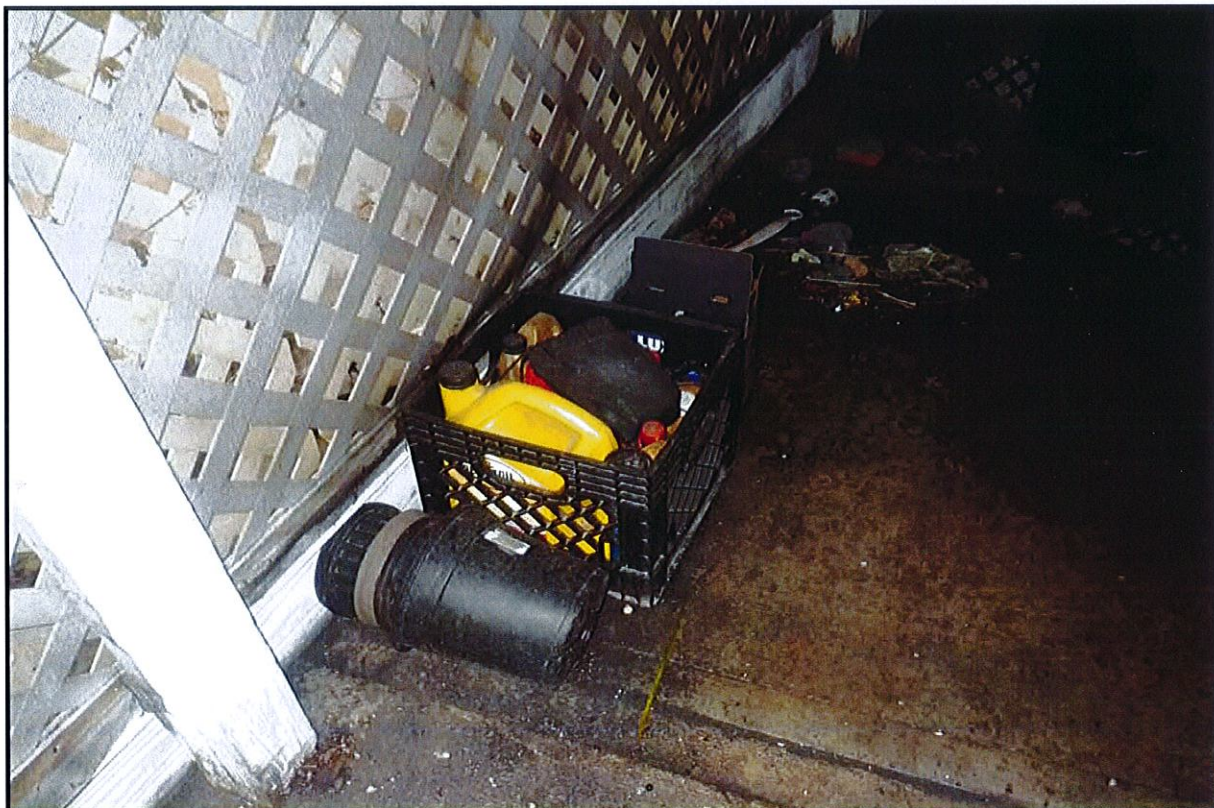
No aboveground storage tanks (ASTs) were observed and no evidence of underground storage tanks (USTs) was observed on the Subject Property. Three small, empty, gasoline containers used to store fuel and several small containers of oil for the lawn equipment were observed onsite. Small containers of domestic cleaning supplies were observed in the residential structure. Several 55-gallon drums containing rainwater, plastic plant containers, several 5-gallon paint containers, a battery, two 5-gallon containers of roof tar, two small containers of asphalt patch, polyvinyl chloride (PVC) piping and fittings, furniture, a lawnmower, and two motors were observed onsite. The containers and drums appeared in good condition with no evidence of leakage. No oily sheen was observed in the puddles of rainwater onsite. Evidence of a former plant nursery was observed. No potential environmental concerns or adverse environmental conditions were observed on the Subject Property during the site walkover.

Photograph No. 22 View of several small oil containers located in a covered patio area.
